Recent Progress in Materials Studies with Acoustic Microscopy

R.C. Bray and C.F. Quate
Edward L. Ginzton Laboratory
Stanford University
Stanford, California 94305

ABSTRACT

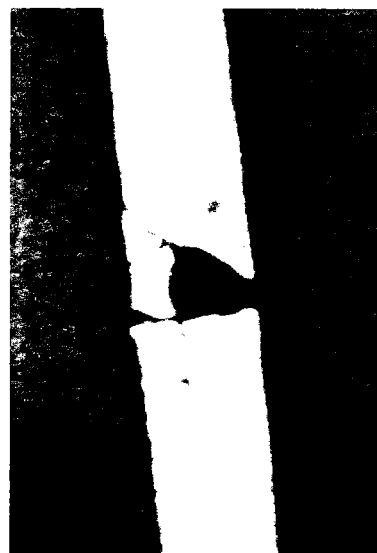
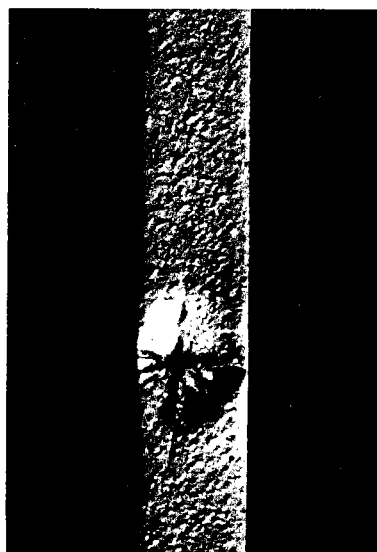
FIGURE 3

In Fig. 3 we see acoustic micrographs at different focal positions of an aluminum line on silicon. The quartz passivation layer on top has been purposely damaged with a diamond indenter. The radial pattern of lines diverging away from the damaged area are mostly not visible in the optical oil immersion micrograph. We believe these are microcracks in the quartz passivation layer and in

the silicon substrate. The width of the Al line is 15 μ and the width of the cracks is near the 5000 Å resolution limit of the acoustic microscope at 2.6 GHz.

(a) ACOUSTIC
1st FOCUS

(b) OPTICAL

(c) ACOUSTIC
2nd FOCUS

ALUMINUM LINE ON SILICON WITH QUARTZ OVERLAY

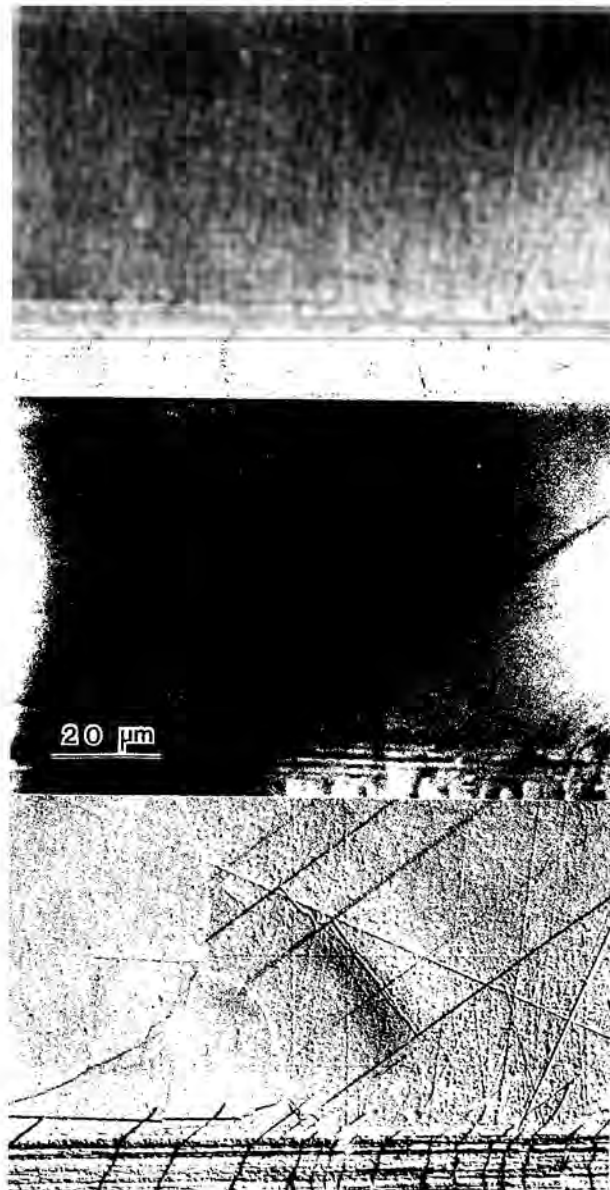
Figures 5 and 6 show polished materials samples in which features are visible in the acoustic micrographs of the polished but unetched samples which are completely invisible in the optical micrographs of the matched sample. Grain boundaries and twin lines visible in acoustic micrographs of the unetched Si sample in Fig. 5 become visible optically only when the sample is etched.

FIG. 5--(Top) Optical micrograph of polished Si sample.
 (Center) Acoustic micrograph of same area $f = 2.5$ GHz.
 (Bottom) Optical micrograph of same area after etching.
